# PHASE I INSPECTION REPORT

## 6 NATIONAL DAM SAFETY PROGRAM

Long Bottom Branch Dam, Inventory Number VA-02702. Buchanan County, Virginia.  
Phase I Inspection Report.

NAME OF DAM: LONG BOTTOM BRANCH DAM  
LOCATION: BUCHANAN COUNTY, VIRGINIA  
INVENTORY NUMBER: VA. NO. 02702

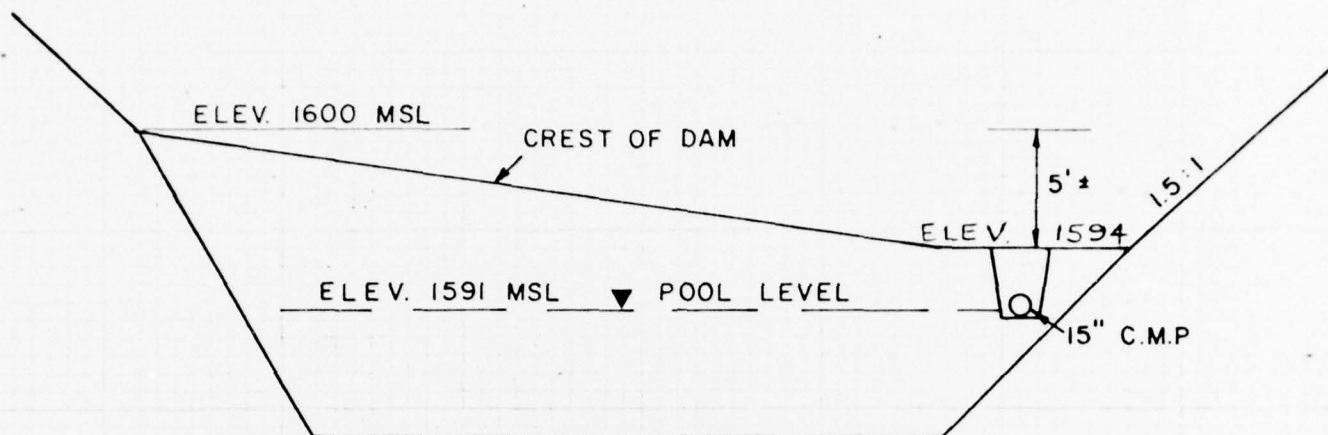
PLATE NO. 2

encountered on the downstream slope along the left abutment and to the right of the dam center where the dam curves into the right abutment. These eroded areas were up to 3 ft wide, 1 to 2 ft deep, and extended from about halfway down the slope to the toe. Three seeps, each flowing at 2 gpm<sup>±</sup> were encountered. Two occur along the toe of the eroded channels or washes and the third was approximately 10 ft right of the right erosion channel along the toe of the slope. Heavy iron staining was associated with the three seeps. Erosion and seepage features are illustrated on Plate 2, Appendix I.

Seepage present along the downstream toe should be monitored quarterly to detect any increase in flow rates which may cause piping within the embankment. Vegetation should be routinely controlled. The slopes and crest of the structure should be mowed twice per year and all existing small trees or saplings removed.
